Communication and Integrity  
in  
Products Liability

## *The Broken Forklift*

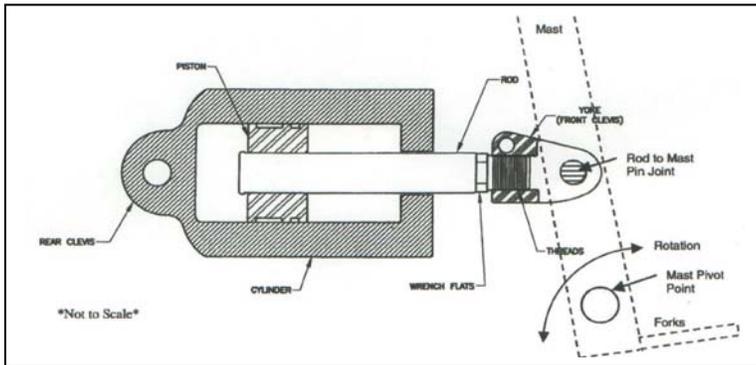
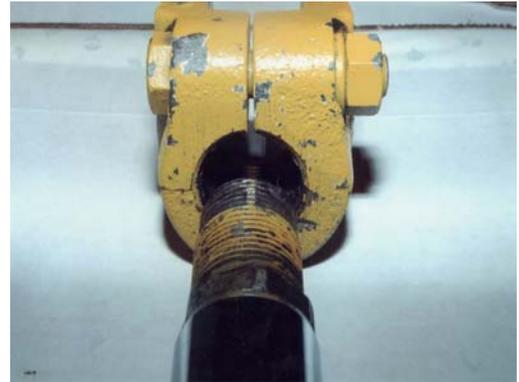
- A hydraulic cylinder on a forklift comes apart dropping a large steel frame which pins and severs several fingers of a worker guiding the frame.
- Review showed that the screw in the cylinder was never inserted correctly and improper maintenance was the cause.
- The matter would have been litigated based upon failure to follow recommended repair and maintenance procedures

John's report and his excellent photographic work made it crystal clear that these rods had not been moved because the paint had not been disturbed. In addition, John also assisted me in connection with the mechanics and physical forces that affect the operation of a forklift. Due to John's assistance and expertise, this case was settled for a substantial sum. Finally, he was cooperative and responsive to my many inquiries.
